**Vulnerabilities to Seismic Hazards in Coastal and  
River Environments:  
Lessons post the  
Canterbury Earthquake Sequence 2010-2012,  
New Zealand**

A thesis submitted in partial fulfilment of the  
requirements for the degree of  
Master of Science in Environmental Science  
at the  
University of Canterbury

**Emma J. Kelland**

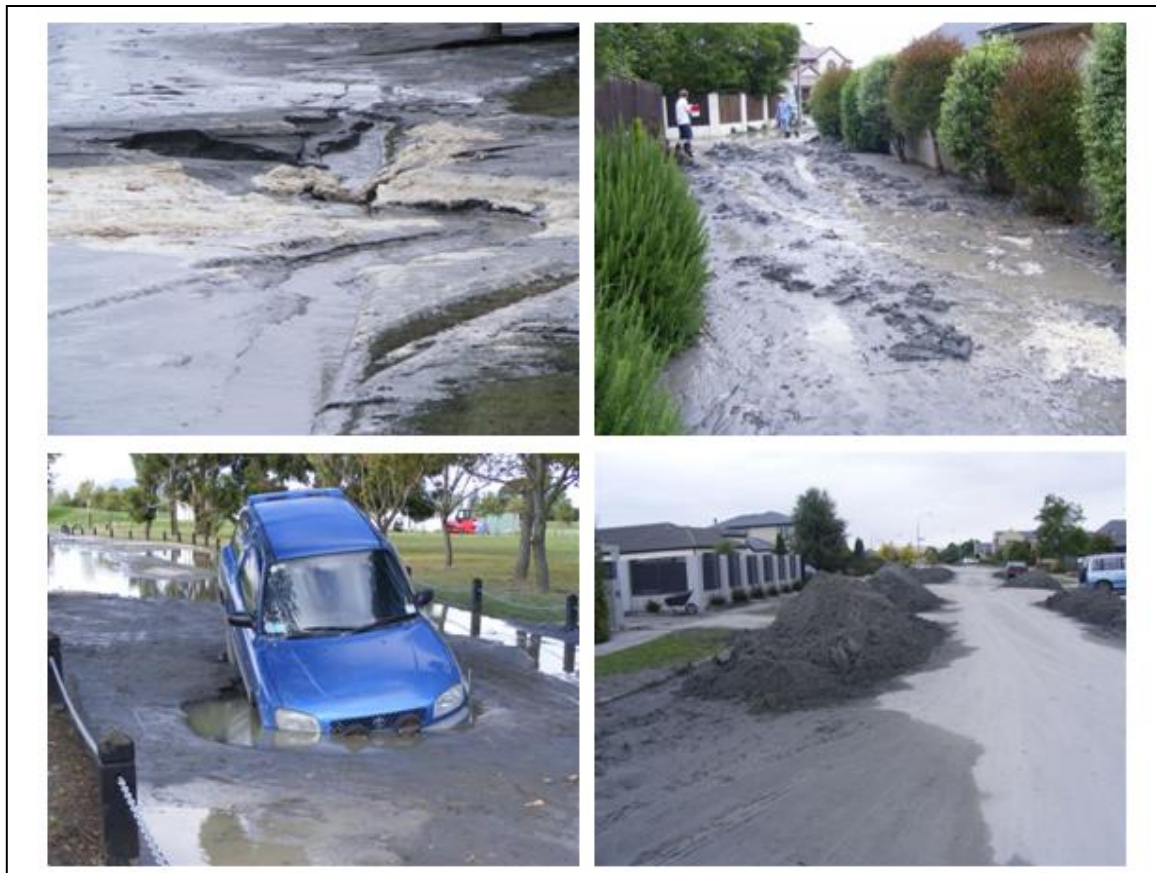
Figure 3.10: Photographs showing the extent of liquefaction, taken after the February 22nd earthquake around the suburbs surrounding the Avon River (Source: Diane Dixey, 2011)

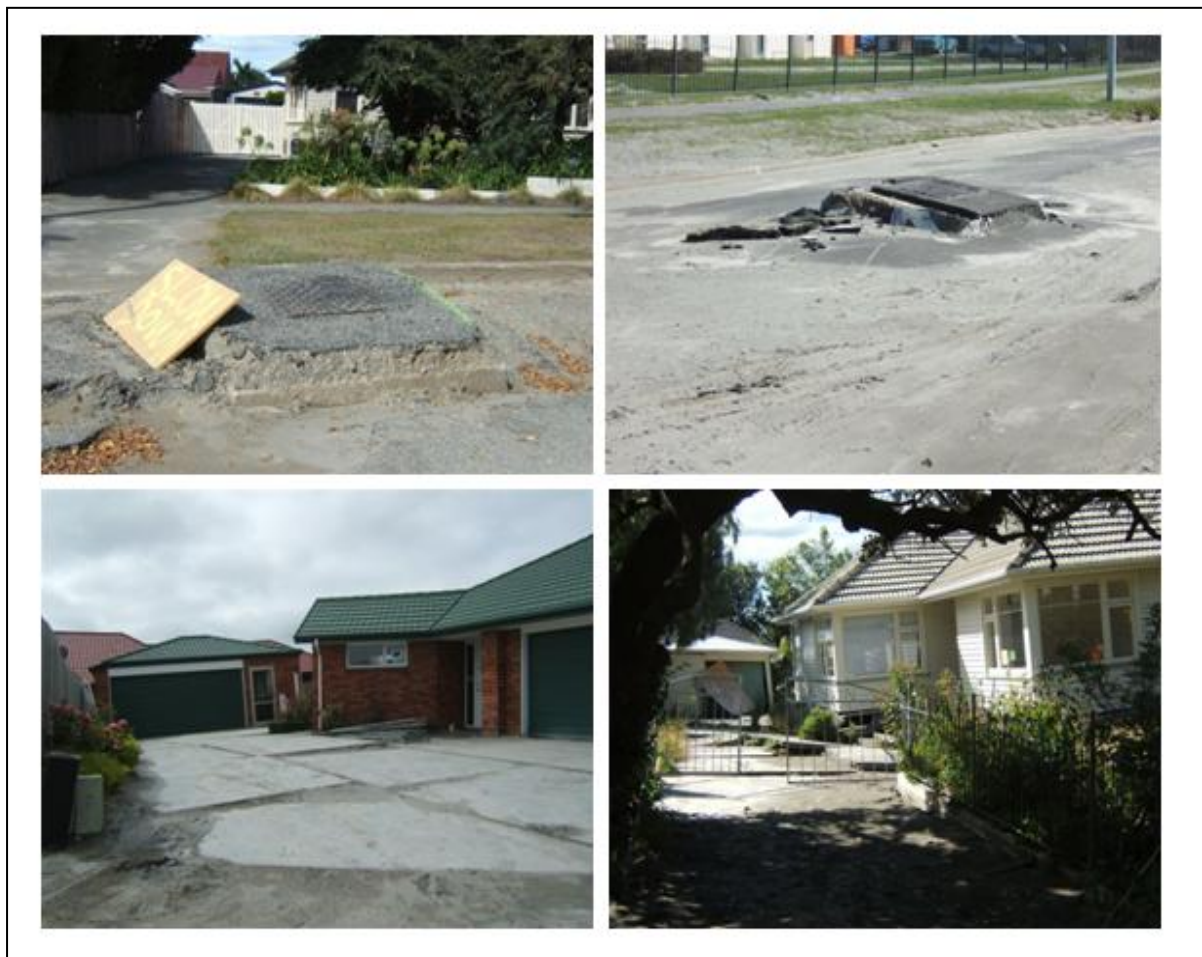
Figure 3.11: Photographs showing the floatation of buried structures and the tilting of homes due to liquefaction (Source: Diane Dixey, 2011)

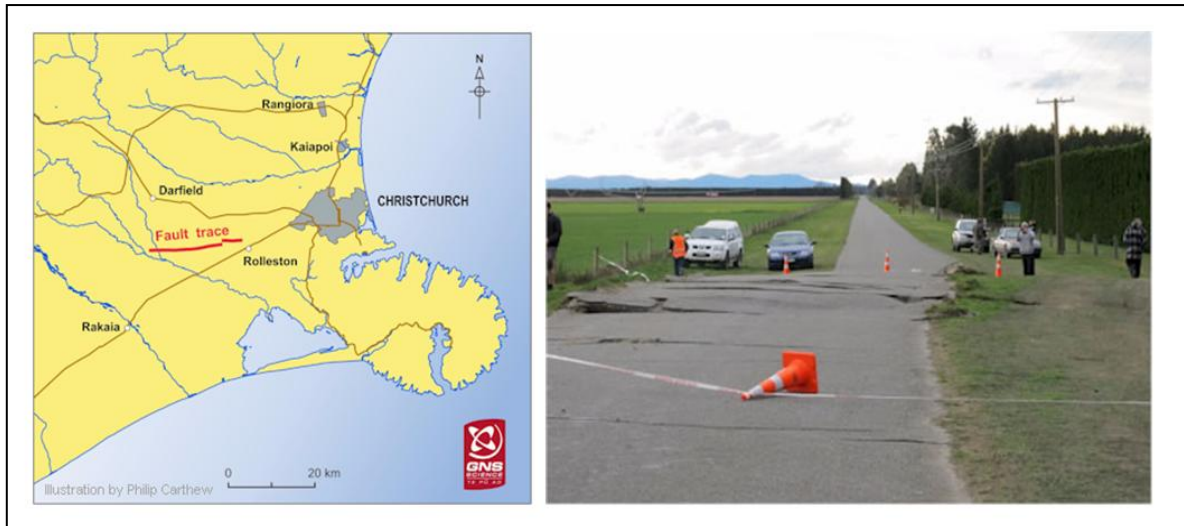
Figure 3.12: Image of the Greendale fault rupture running through a road (Source: GNS Science, 2012)

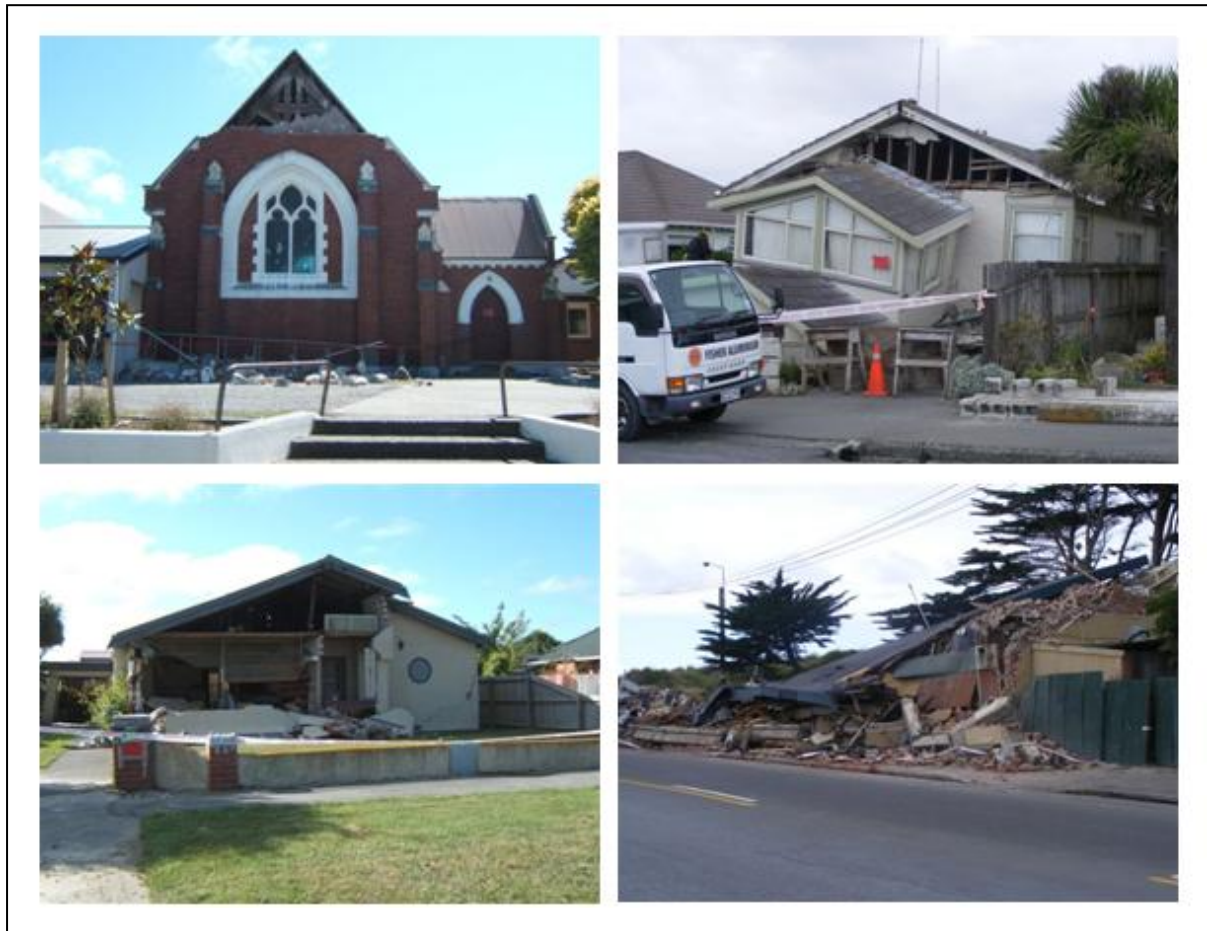
Figure 3.15: Photographs showing the collapse of homes and large unreinforced masonry buildings (Source: Diane Dixey, 2011)

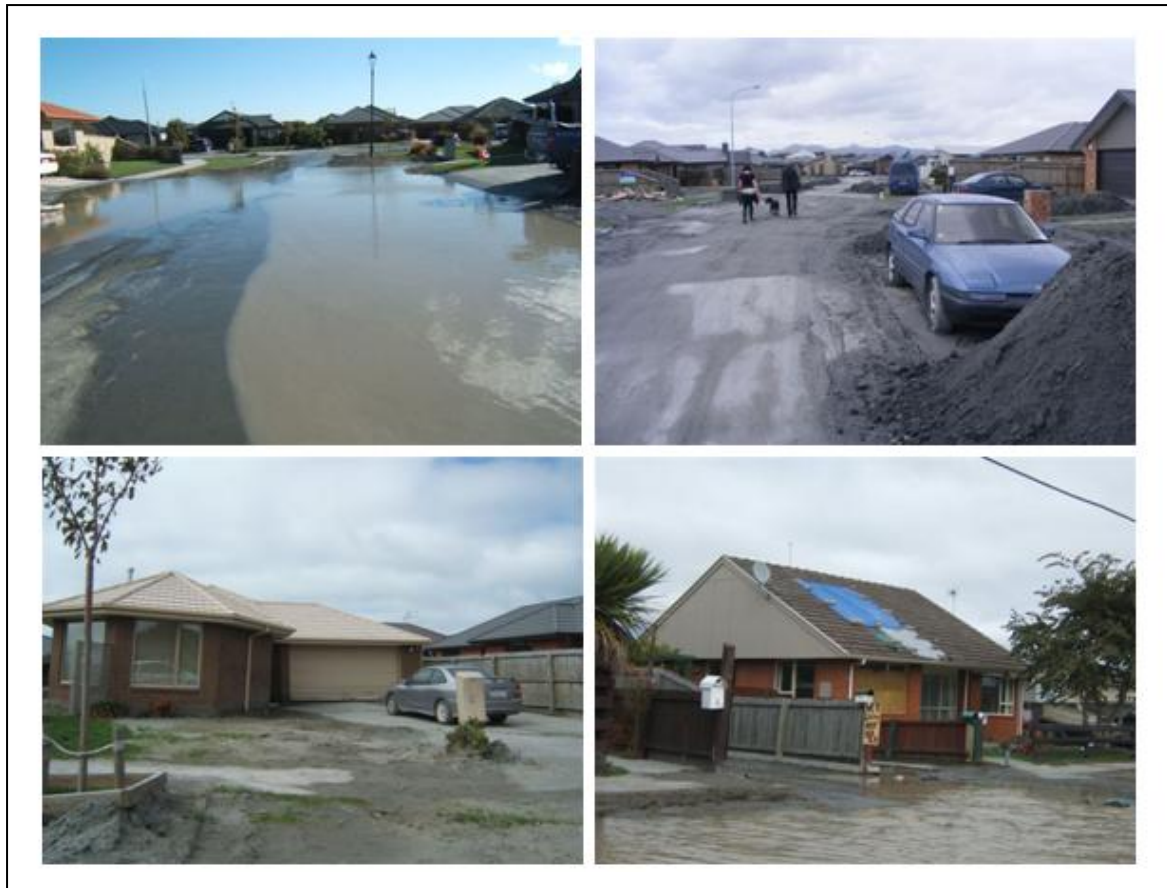
Figure 3.16: Top photos show liquefaction and flooding in eastern suburbs and the bottom row shows damage to homes, note that damage is suffered to both older and new homes (Source: Diane Dixey, 2011)

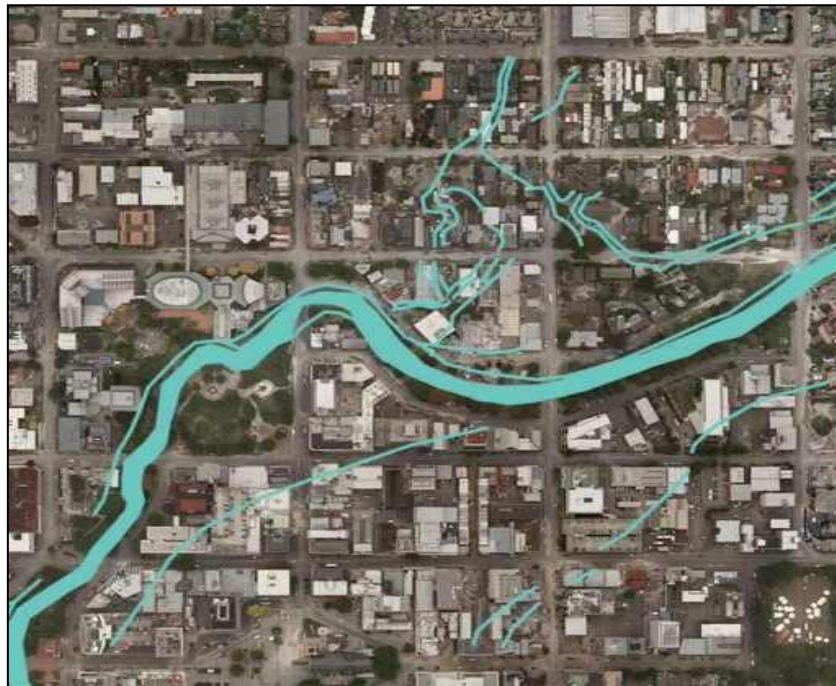
Figure 4.2: Past and present streams in central Christchurch as mapped in March 1850, superposed on aerial photography from 2011. Streams digitised from the Black Map of Christchurch, March 1850. (Source: Lucas Associates, 2011)

Fan building was controlled by fluctuations in river loading between climatic highs and lows during the Pleistocene as well as sea level fluctuations influencing river regimes and, possibly, by tectonic uplift in the Canterbury foothills. These processes all possibly played a part in the progressive eastward shift in river gravel fan apices (Wilson, 1976). The lowest shore line recorded in Canterbury was situated about 50 km seaward and 130 m lower than its present positions (Forsyth *et al.* 2008). Christchurch City itself has also been built upon past and present channels of a number of spring fed river channels (Figure 4.2).

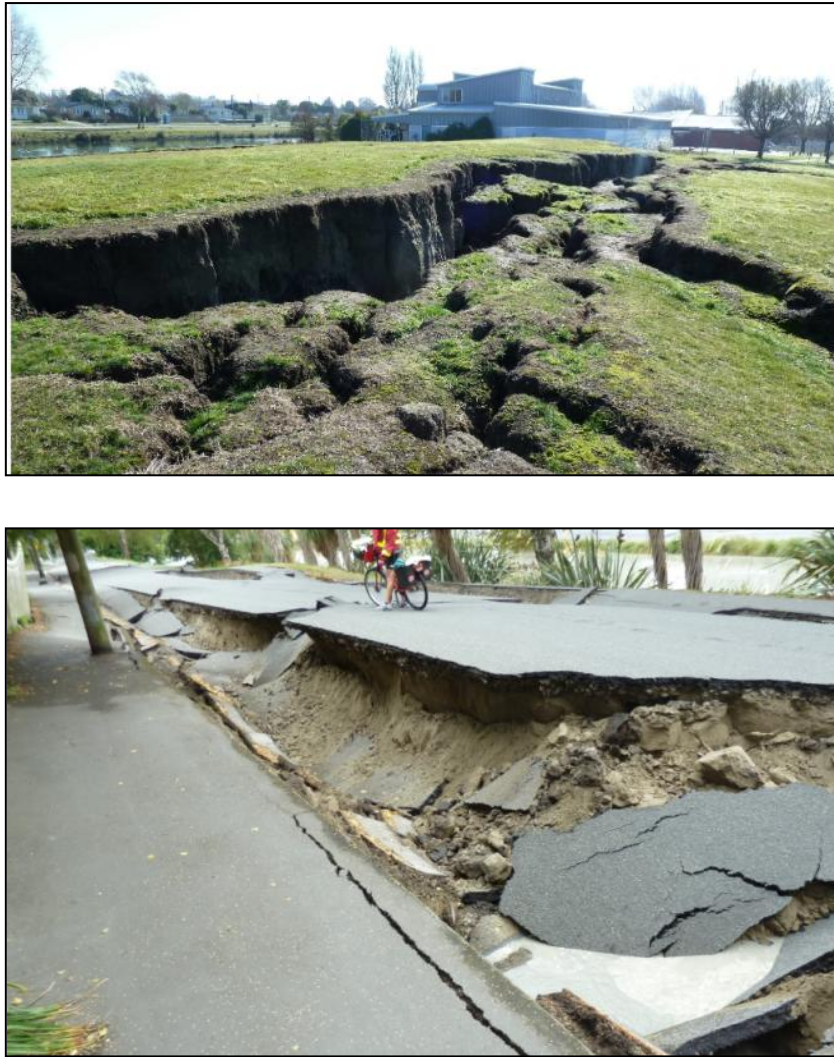
Figure 4.5: Photos showing the extent of lateral spreading damaging land and roads around the Avon River after the February earthquake struck (Source: Tonkin and Taylor, 2011)

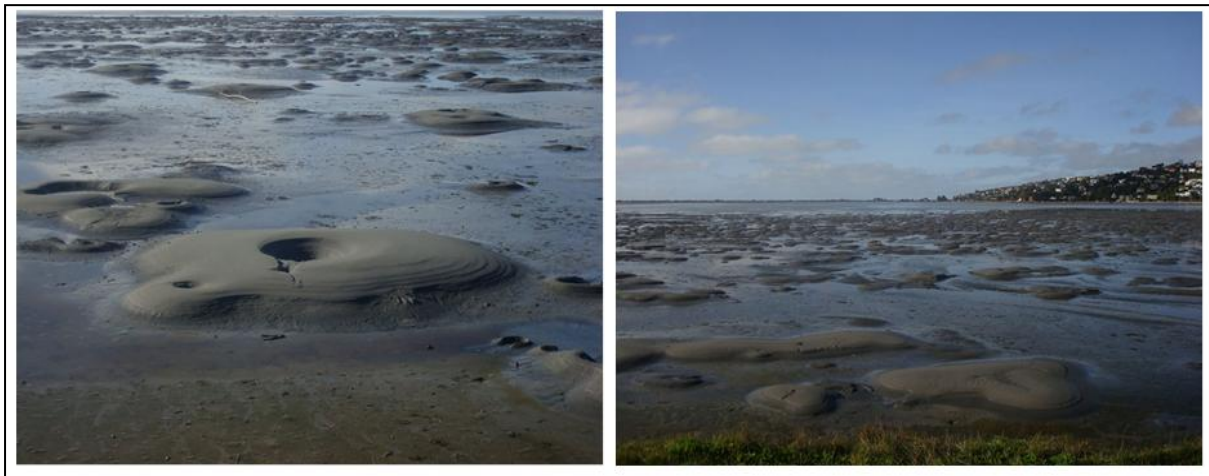
Figure 4.11: Photos of the liquefaction mounds that covered the Avon Heathcote Estuary (Source: Red Zone Tours, 2012)

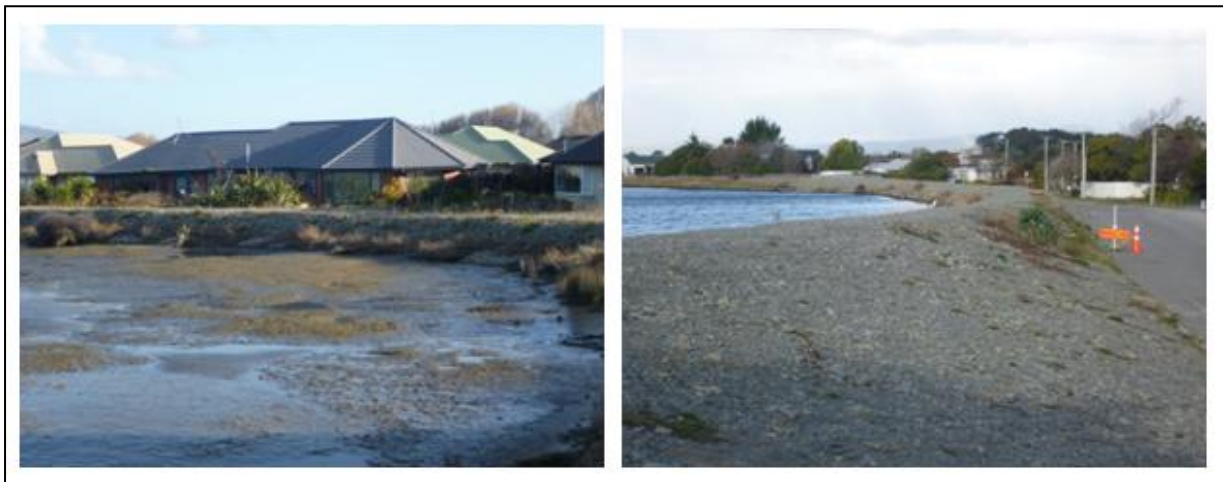
Figure 4.12: Photos showing the emergency stop banks that were created around Bexley Wetland (left) and along the Avon River (right). Photos show the higher water level compared to that of the land.

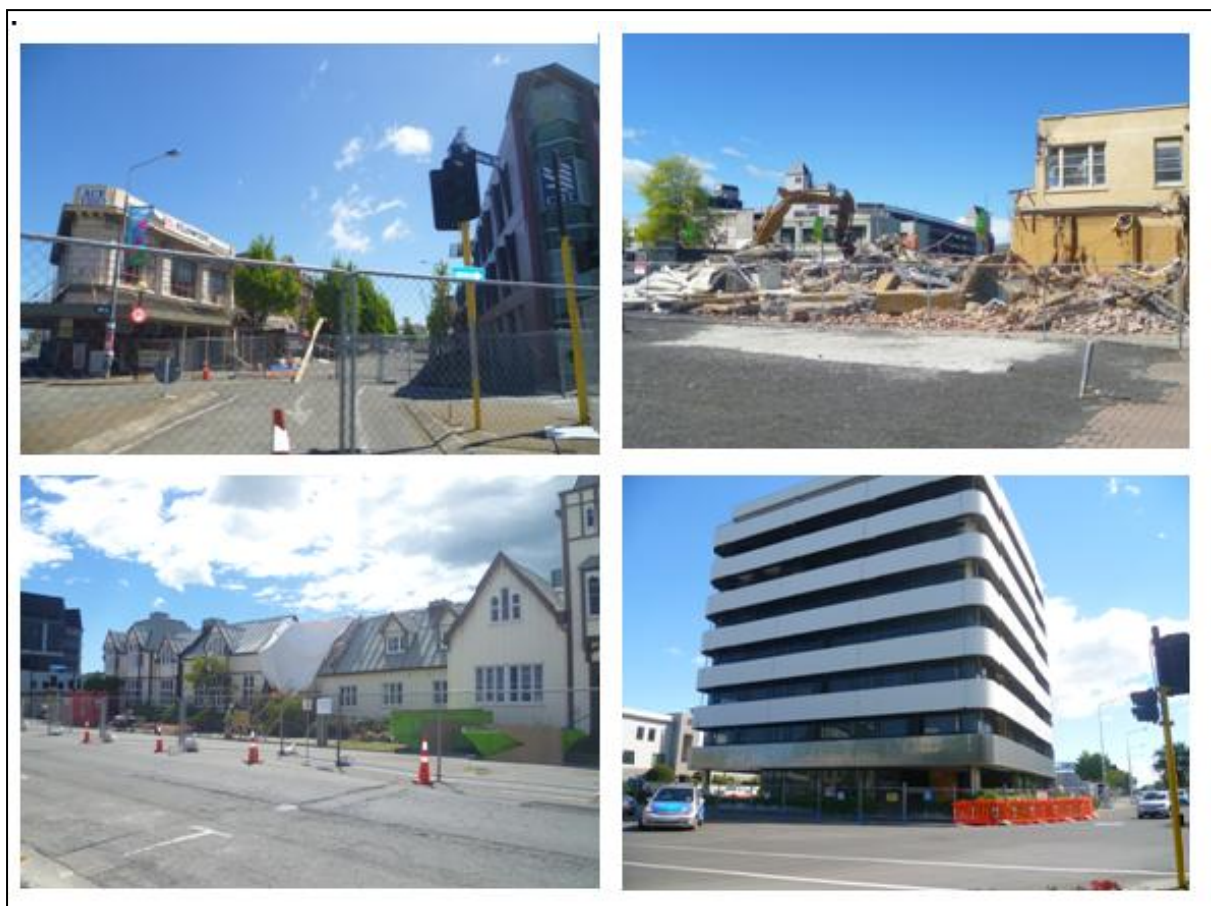
Figure 5.5: Photos showing the areas of the CBD that are still cordoned off and buildings that are have been demolished and that are destined still for demolition (October 2012).

The Christchurch CBD suffered extensive structural and infrastructural damage as a result of the February earthquake. As of the 22<sup>nd</sup> of March 2011 the first assessments of the entire city had been undertaken in order to establish building safety, with each categorised according to indicator tag system, red, yellow or green (Table 5.1). Many buildings within the CBD withstood the effects of the earthquake from a structural perspective but were considered unusable because of damage to facades, ceilings, partitions and contents, and the risk from falling panels, glass and masonry that could cause injury or death (Baird *et al.* 2011). The entire CBD within the ‘four avenues’ (Bealey Ave, Morehouse Ave, Deans Ave and Fitzgerald Ave) was cordoned off and heavily guarded to protect people from the damaged buildings and prevent looting. The CBD red zoned cordon has also been significantly reduced to date (Figure 5.4). Because initial tagging only gave a preliminary assessment of building safety, further assessments were undertaken during the remainder of 2011. To date (October 2012) More than 700 buildings within the Christchurch CBD have been or are still to be demolished, because they are either unsafe or cannot be economically repaired (Figure 5.5).

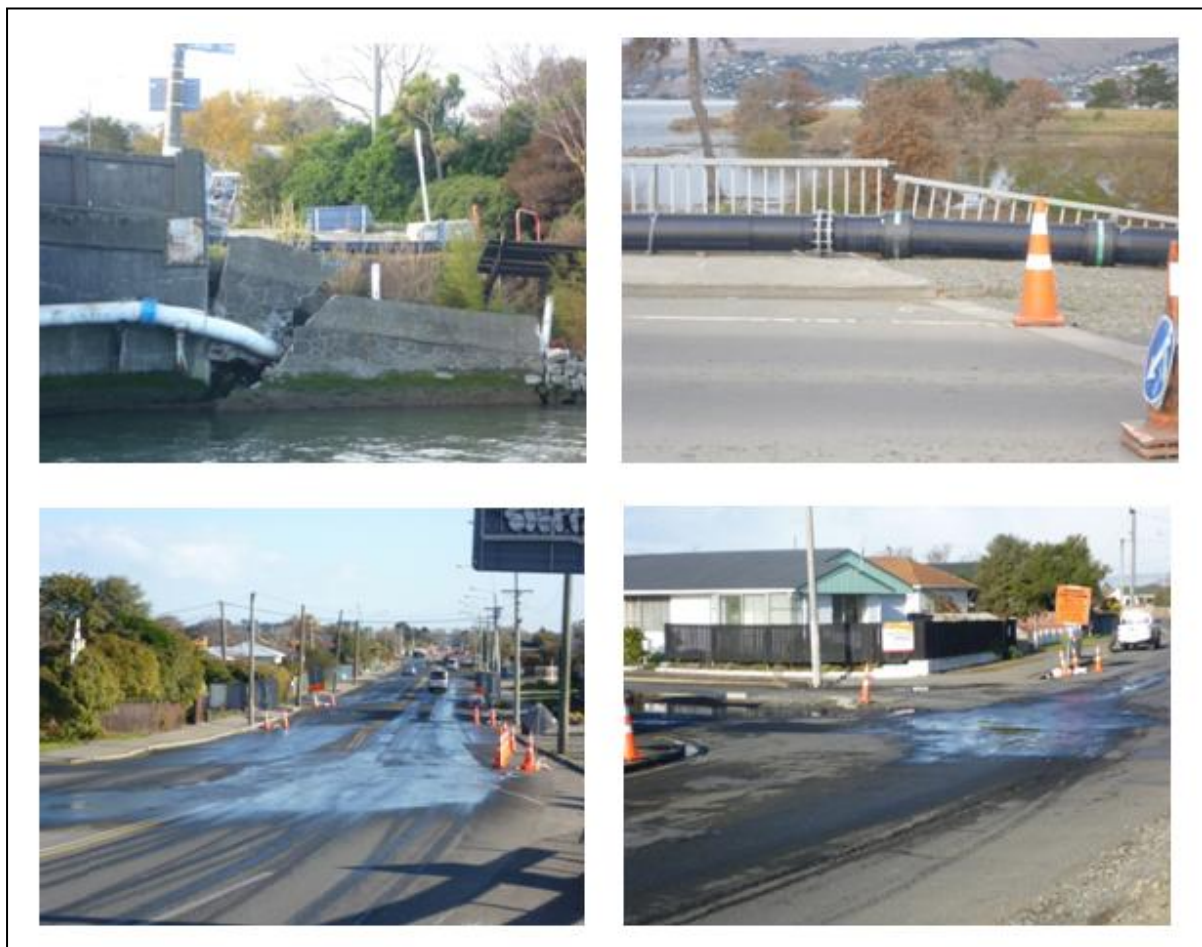
Figure 5.7: Top photos show the damage that occurred to bridges and their pipelines in eastern Christchurch. Temporary pipelines had to be put on the surface of the broken bridge. The bottom photos show damages to roads (June, 2012)

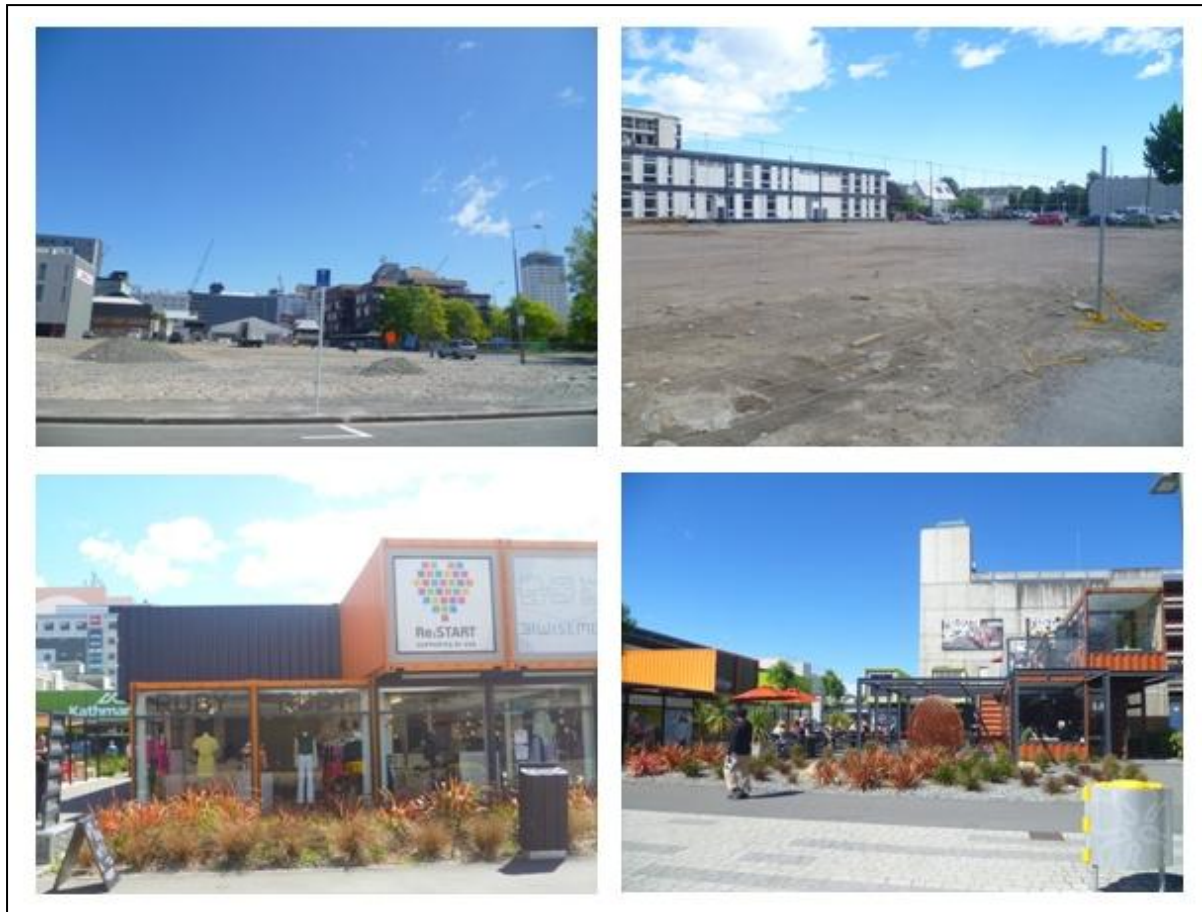
Figure 5.9: Photos on the top shows the clearing of the buildings and land within the CBD in preparation for re-development and the photos on the bottom show what the Re-start container mall on Cashel street looks like (October 2012)

After the emergency phase of recovery the phase of rebuilding begins. The first part of the rebuilding phase began with assessments of the land and buildings in the residential areas and the demolition of buildings within the CBD. Bringing down damaged buildings and opening the CBD back up for the public was a priority of the recovery process. A highlight within this progress of recovery was the opening of the Cashel Street Container Mall which highlighted the first step in revitalising Christchurch's CBD and welcoming the public back in (Figure 5.9).
